4.6 HYDRAULIC DROPS

4.6.2 Existing Conditions and Deficiencies

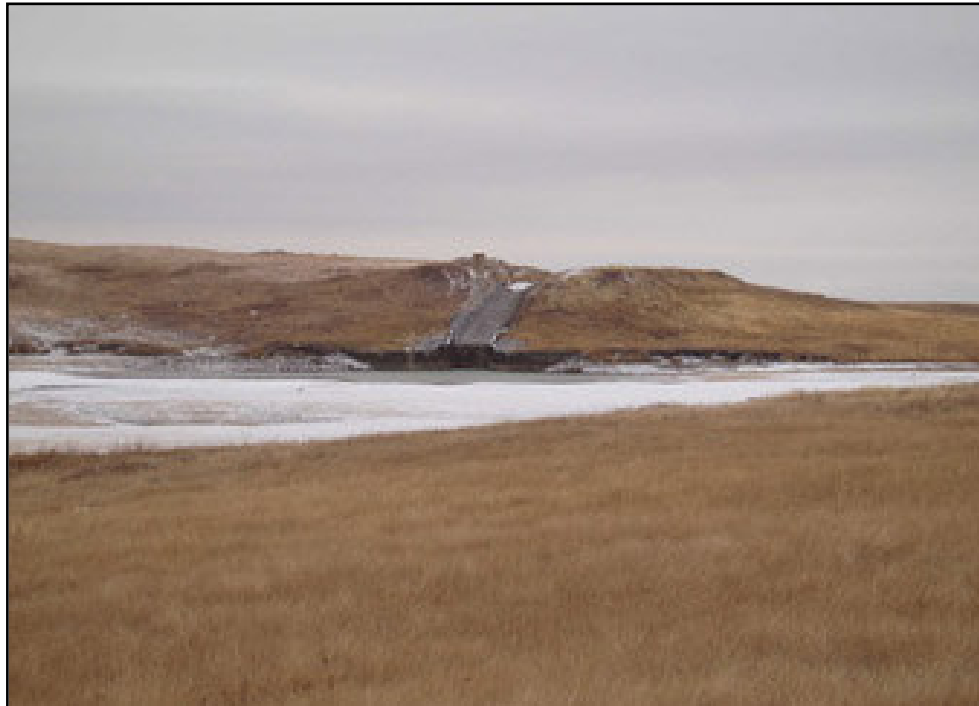
Figure 4.6.1 Looking west towards Drop No. 1 (11/10/04).

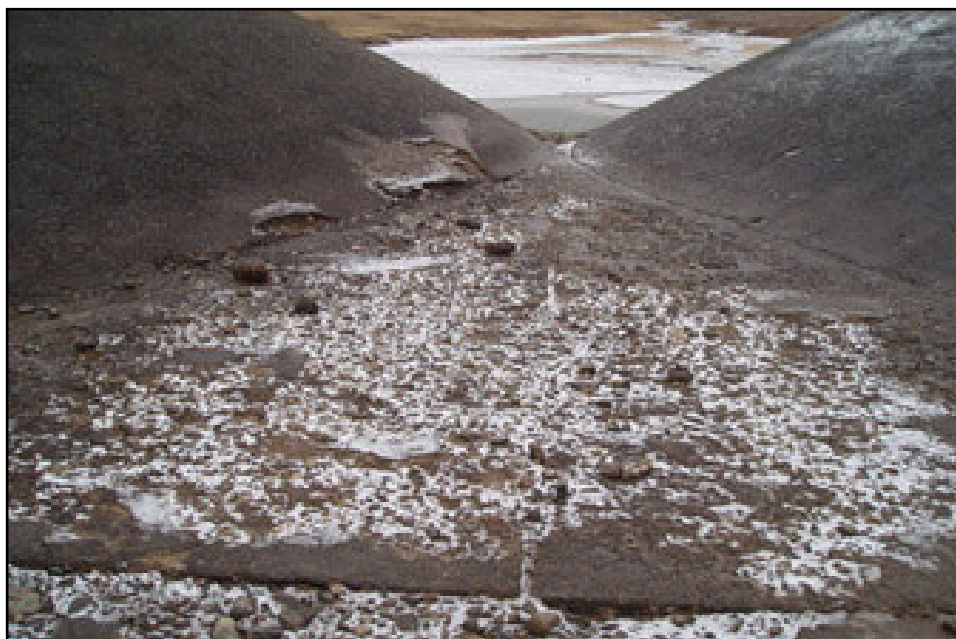
Drop No. 1 has a total length of approximately 215 feet and a vertical drop of approximately 36.5 feet. An overall view of the structure is shown in Figure 4.6.1. This structure appears to be in the best condition of all five drops. The spillway chute downstream of the V-notch has experienced moderate concrete spalling. However, the approach slab has experienced moderate to severe spalling as shown in Figure 4.6.2.

Figure 4.6.2 Looking at approach section of Drop No. 1. Note condition of concrete (11/10/04).

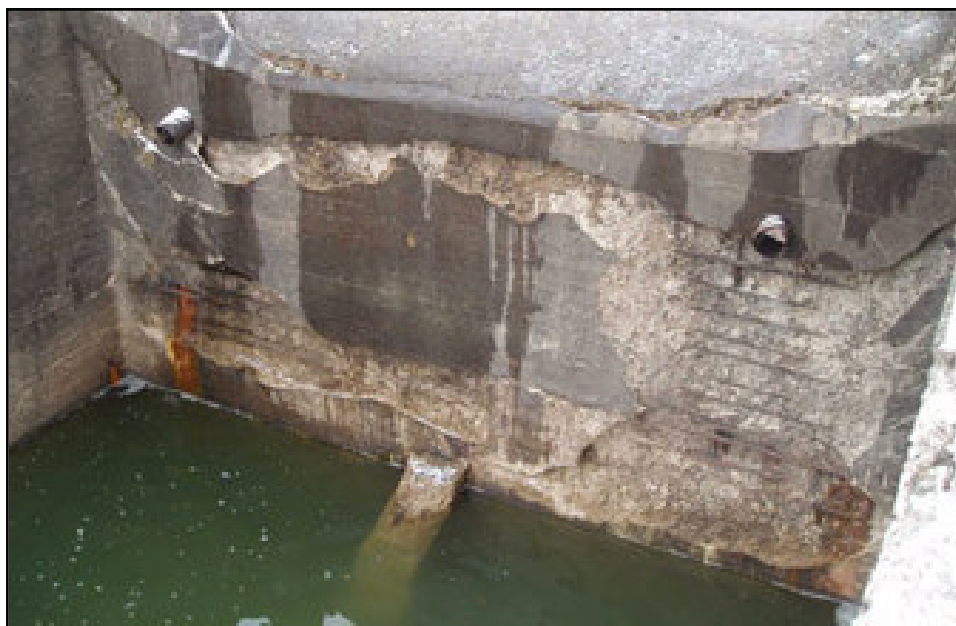
Water in the plunge pool prevented a complete inspection of the condition of the lower walls or slab. Rebar is exposed on the visible portion of the vertical face just downstream of the chute as shown in Figure 4.6.3. There is also a large crack, with exposed rebar, at the left wall to chute slab interface just upstream of the vertical drop as shown in Figure 4.6.4.

Figure 4.6.3 Looking at vertical face downstream of chute section of Drop No. 1 (11/10/04).

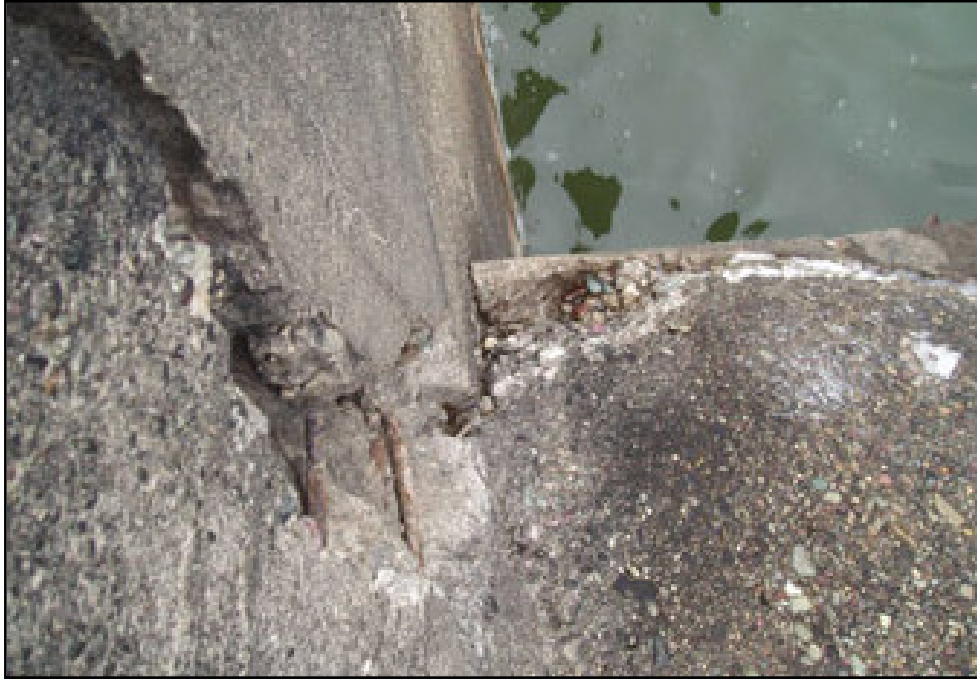
Figure 4.6.4 Looking at left (north) retaining wall at terminus of chute section (Drop No. 1). Note structural cracking (11/10/04).

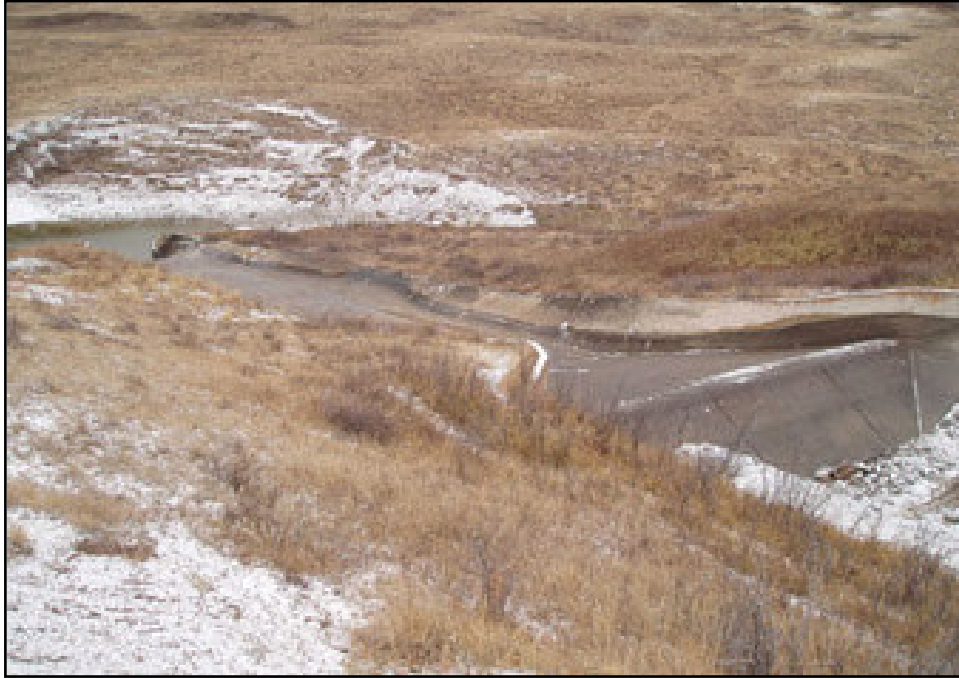
Figure 4.6.5 Downstream view of Drop No. 2. Note stilling basin landslide in background (11/10/04).

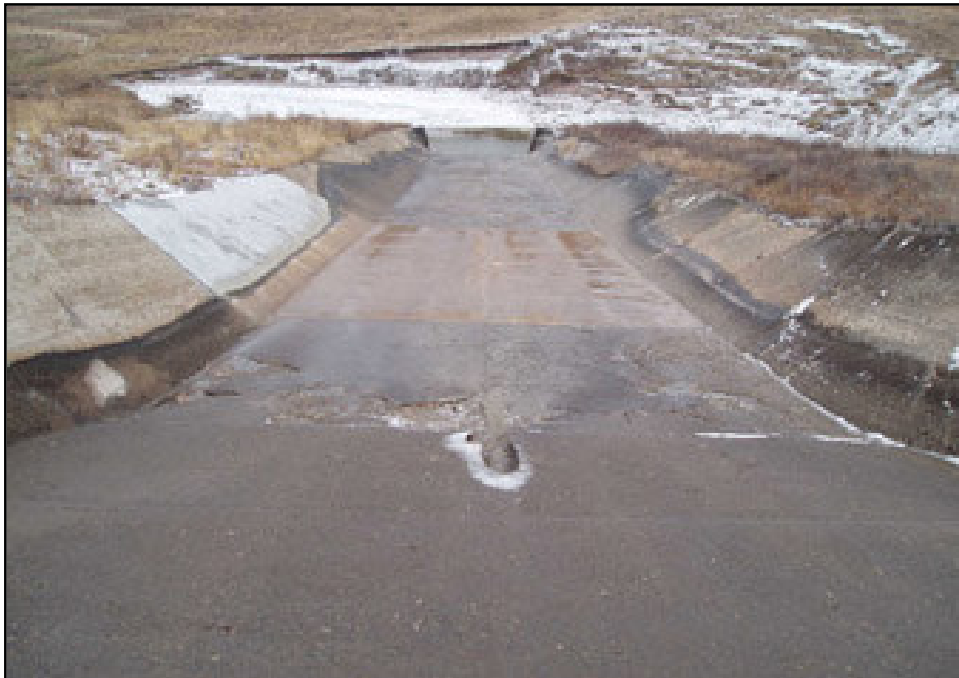
Drop No. 2 has a total length of approximately 205 feet and a vertical drop of approximately 29.5 feet. An overall view of the structure is shown in Figure 4.6.5. A section of this structure (slab and sloping side walls) was replaced after a partial failure that occurred in 2002 as shown in Figure 4.6.6.

Figure 4.6.6 Downstream view of chute of Drop No. 2. Note new section replaced in 2002 and extent of landslide in background (11/10/04).

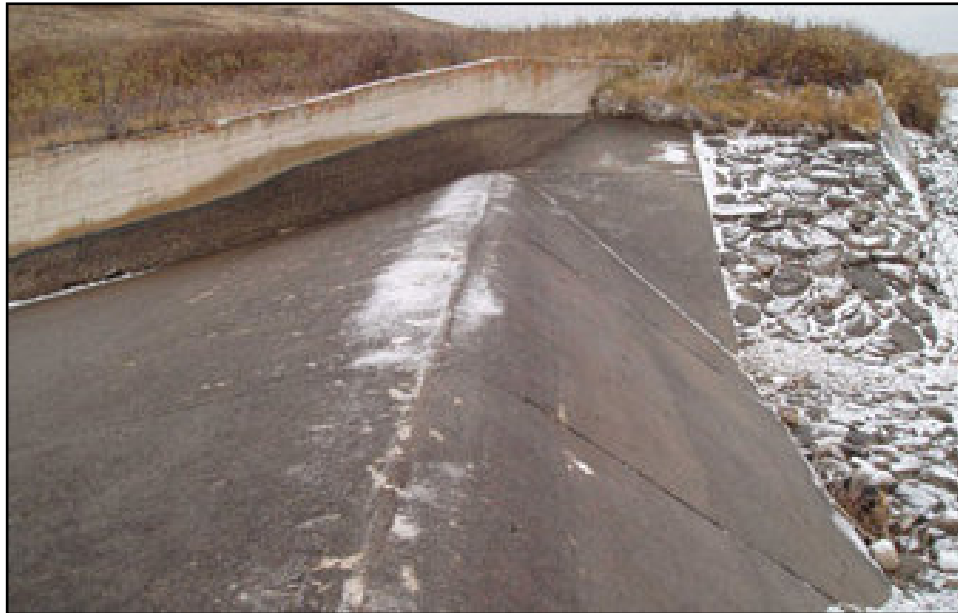
The ogee crest appears to be in good condition as shown in Figure 4.6.7. The slab upstream and downstream of the replaced section shows widespread spalling. The chute slab is shown in Figure 4.6.8, upstream and downstream of the replaced section, respectively. The condition of the foundation under the entire structure is unknown.

Figure 4.6.7 View of ogee crest of Drop No. 2 (11/10/04).

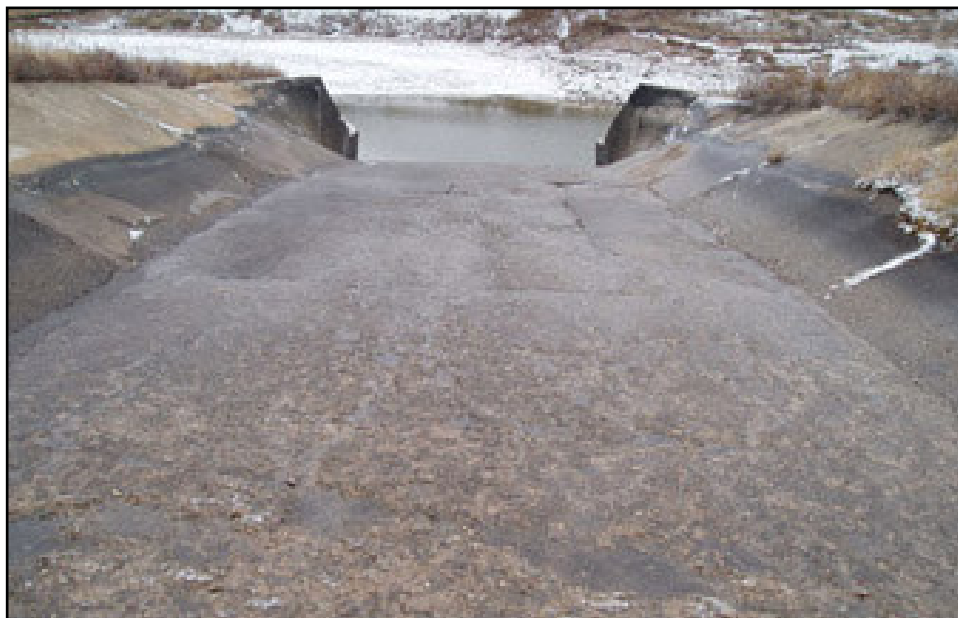
Figure 4.6.8 Downstream view of chute section of Drop No. 2 (11/10/04).

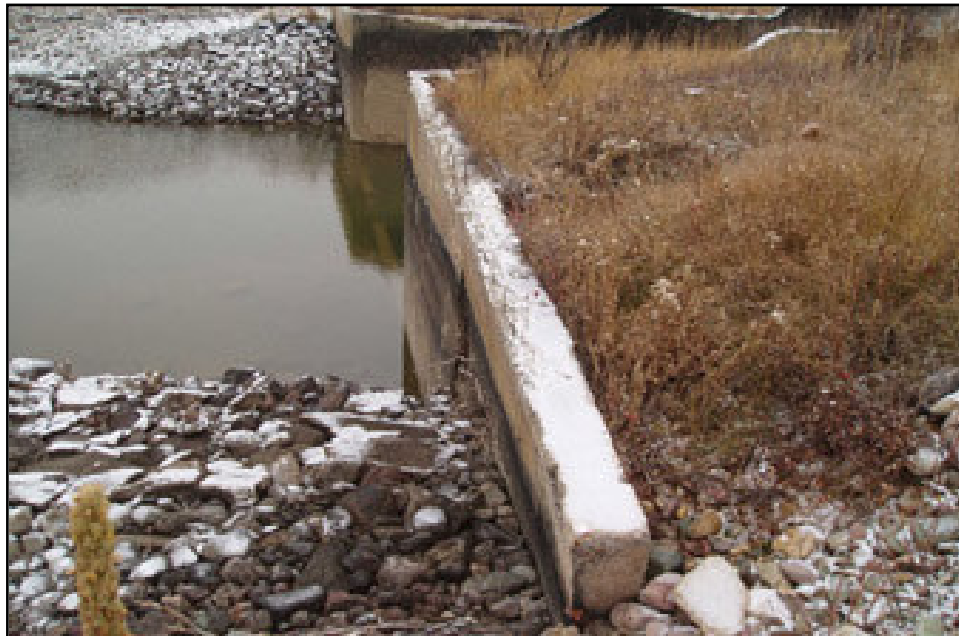
A section of the left wingwall (perpendicular to end of the plunge pool) appears to be failing as shown in Figure 4.6.9. Rebar is exposed on the downstream face of this wall and a seep hole has developed along the opposite side of this wall as shown in Figures 4.6.10 and 4.6.11, respectively. Sink holes are an indication of the loss of backfill soil due to seepage. Also, severe deterioration of the concrete has occurred on the vertical face of the plunge pool with rebar exposed as shown in Figure 4.6.12. Water in the plunge pool prevented a complete inspection of the condition of the lower walls or slab. It appears that the downstream section of the chute floor, just before the vertical drop, is possibly settling as evidenced by the type of cracking and opening of joints within the chute section also shown in Figure 4.6.12.

Figure 4.6.9 Left (north) wingwall of Drop No. 2 is failing (11/10/04). Also, see Figures 4.6.10 and 4.6.11.

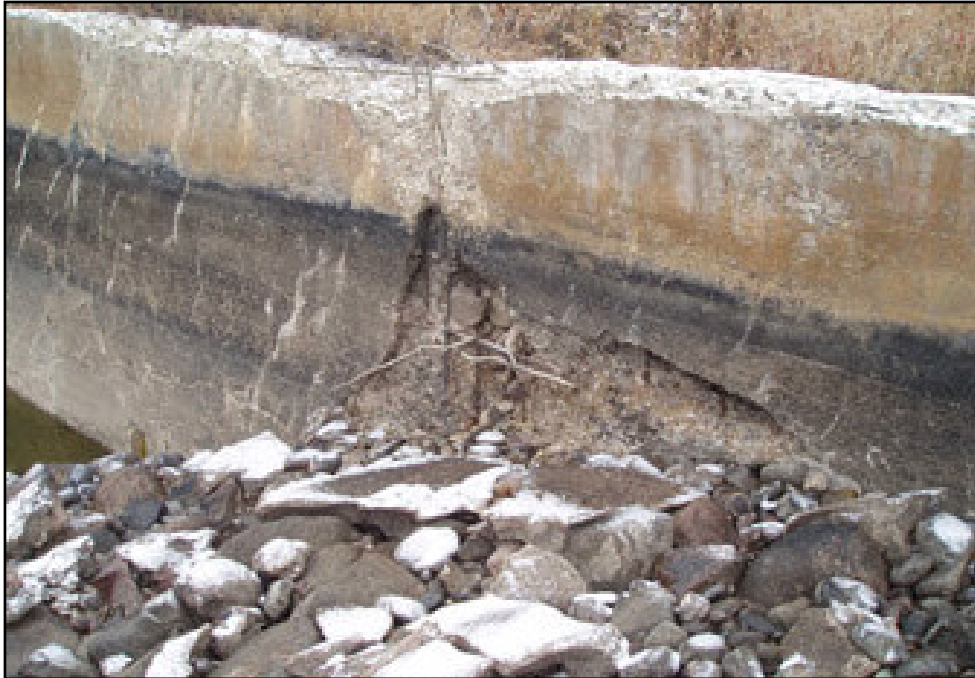
Figure 4.6.10 North wingwall of Drop No. 2. Note wall displacement, concrete loss and exposed reinforcement (11/10/04).

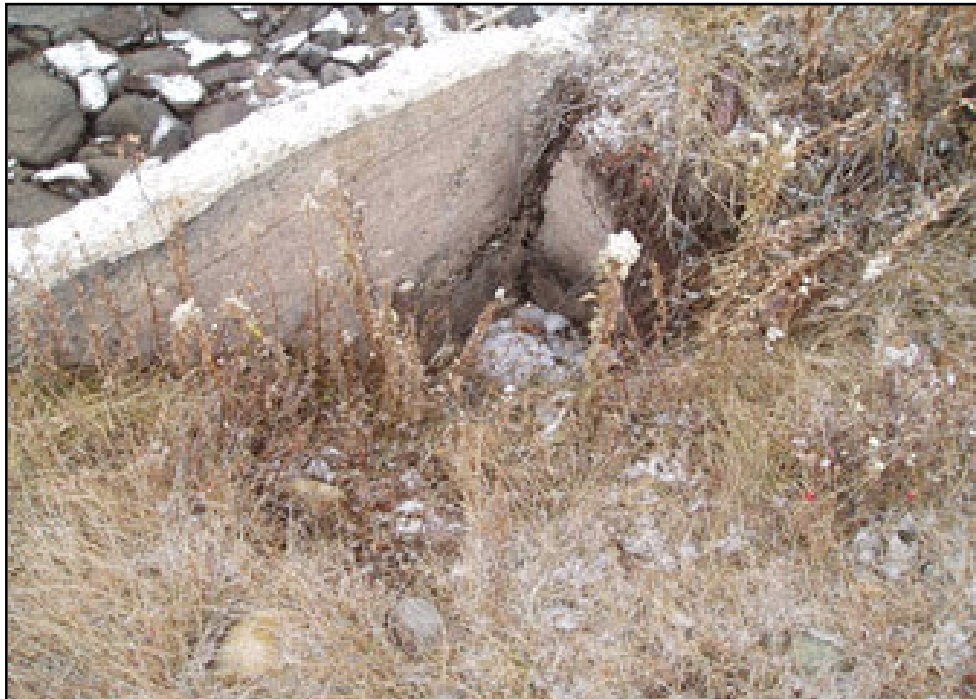
Figure 4.6.11 Sink hole developing behind north wingwall of Drop No. 2 (11/10/04).

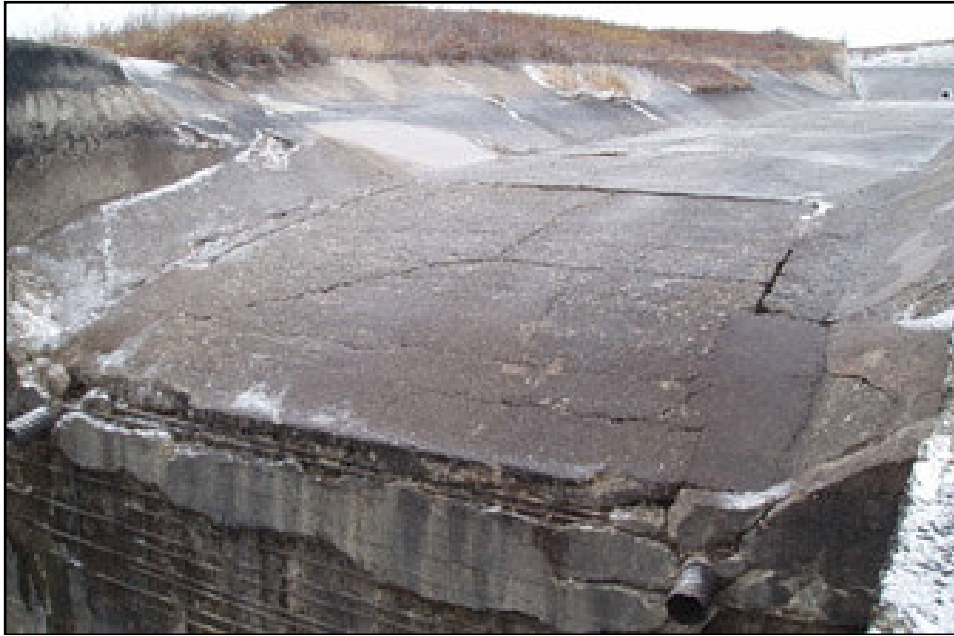
Figure 4.6.12 Looking at terminus of chute section for Drop No. 2. Note condition of plunge pool headwall and end of chute (11/10/04).

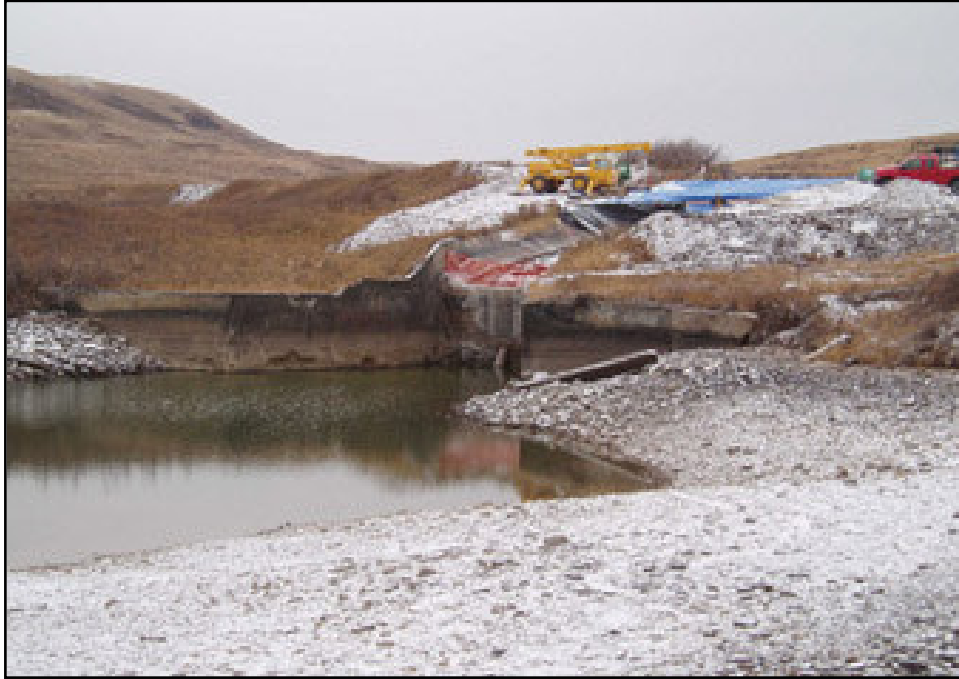
Figure 4.6.13 Looking upstream toward Drop No. 3 (11/10/04).

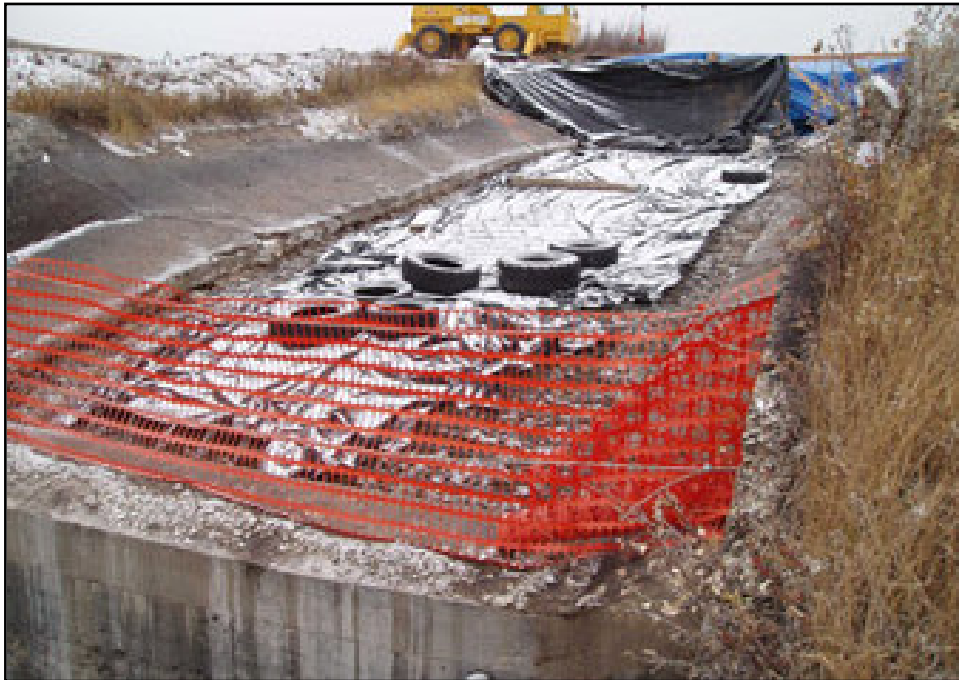
Drop No. 3 has a total length of approximately 139.5 feet and a vertical drop of approximately 27.8 feet. An overall view of the structure is shown in Figure 4.6.13. At the time of the inspection, a BOR maintenance crew was in the process of replacing the entire chute slab from the first joint downstream of the ogee crest to the end of the chute. This work is shown in Figures 4.6.13 and 4.6.14. In talking with the crew, upon removal of the slab, there was no evidence of piping or voids observed in the foundation materials below the chute slab. The foundation was noted to consist of large cobblestones with drains along the full length of the chute at the slab to chute wall interface.

Figure 4.6.14 Photo shows maintenance work being performed on Drop No. 3 (11/10/04).

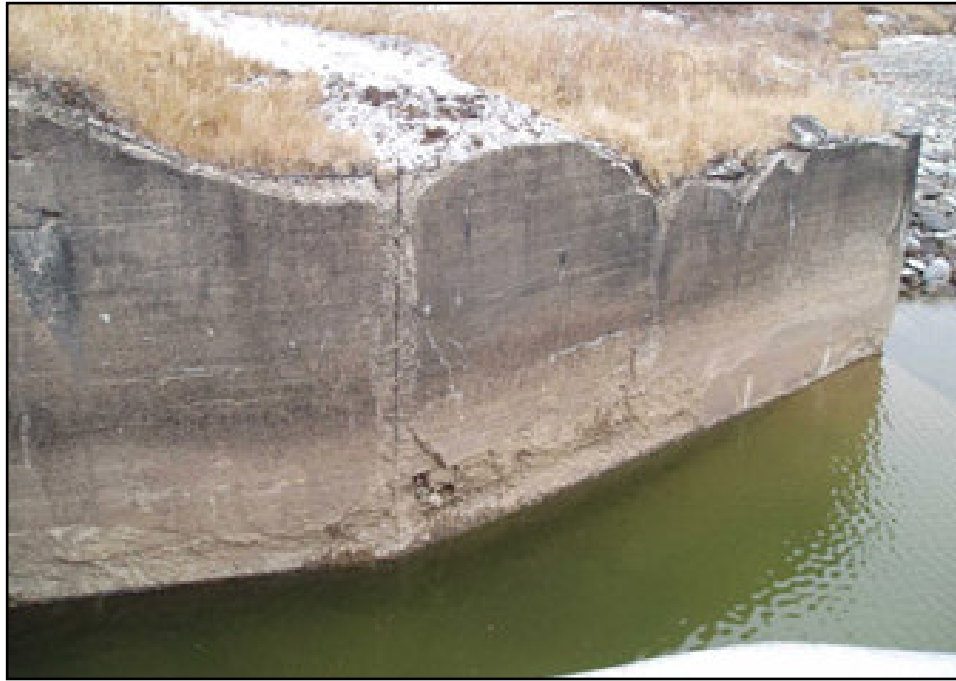
The crew pointed out that they had recently filled a large sinkhole on the backside of the north (left) training wall just downstream of the end of the chute. This sinkhole extended the full height of the training wall. At the base of the wall at the location of the sinkhole, the concrete deterioration has resulted in a hole all the way through the wall. Figure 4.6.15 shows this deteriorated area and the fill placed by BOR crews. The sinkhole formed due to moisture seepage which caused the soil to pipe or “wash” through the hole in the concrete.

Figure 4.6.15 Looking at north (left) training wall in plunge pool of Drop No. 2. BOR crews filled large sink hole behind wall (11/10/04).

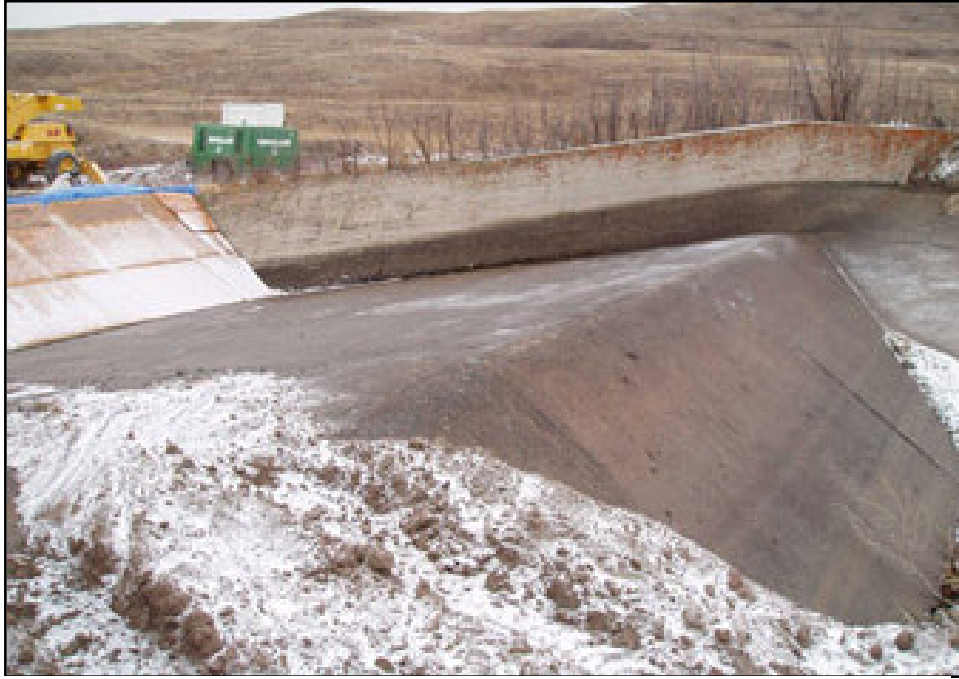
Figure 4.6.16 Ogee section of Drop No. 3 (11/10/04).

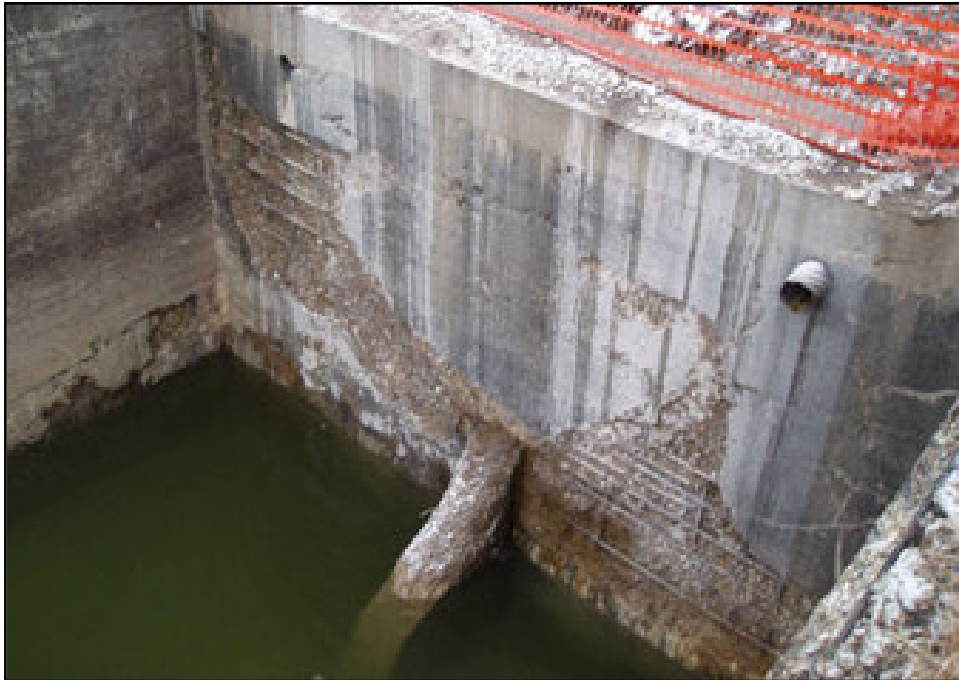
The approach and ogee crest section appear to be in good condition as shown in Figure 4.6.16. The concrete is deteriorated with exposed rebar on the vertical face of the plunge pool as shown in Figure 4.6.17. Water in the plunge pool prevented a complete inspection of the condition of the lower walls or slab. Extensive concrete deterioration has also taken place near the base of the retaining wall on the right side of the plunge pool as shown in Figure 4.6.18. As has already happened at the base of the left wall and as discussed in the previous paragraph, it may only be a matter of time before the concrete deterioration extends through the thickness of the right training wall resulting in similar piping and subsequent sinkholes on the backside of these walls.

Figure 4.6.17 Condition of plunge pool headwall at drop No. 3 (11/10/04).

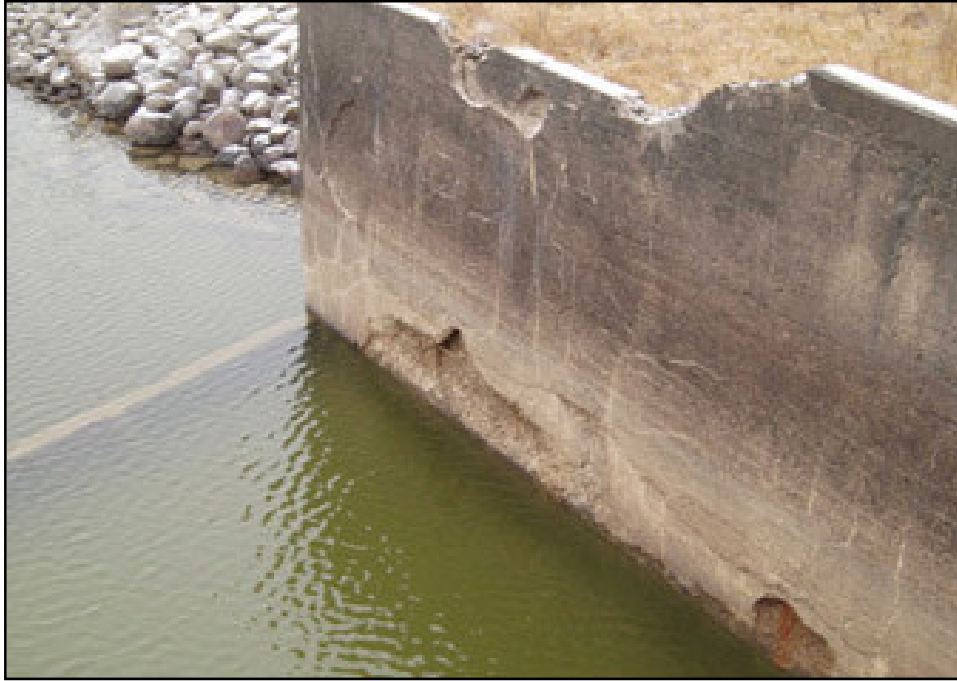
Figure 4.6.18 Typical condition of south (right) training wall at Drop No. 3 (11/10/04).

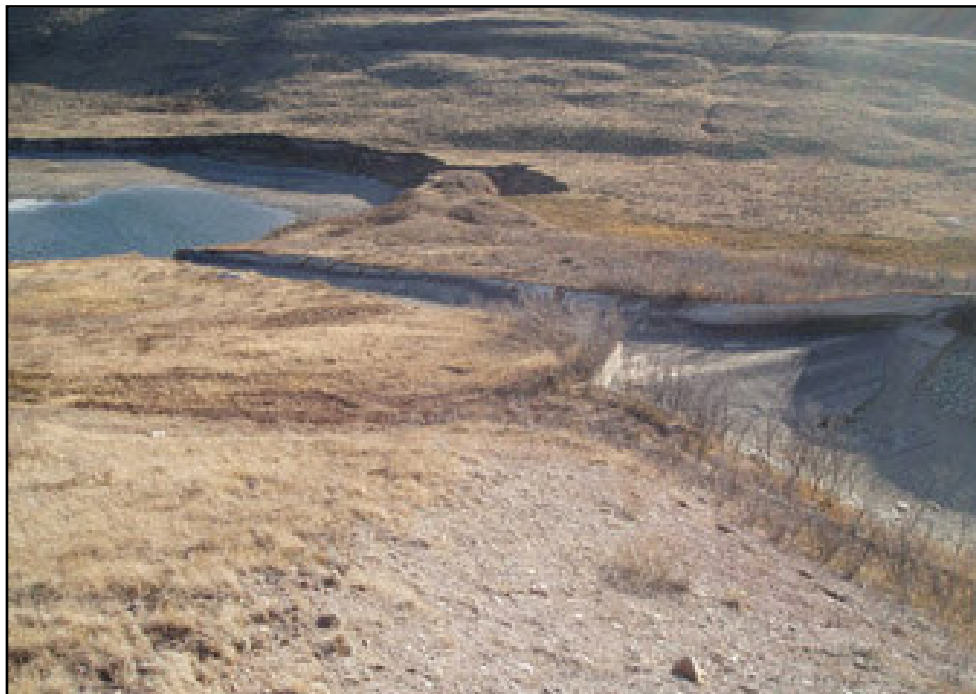
Figure 4.6.19 Looking downstream at Drop No. 4 (11/10/04).

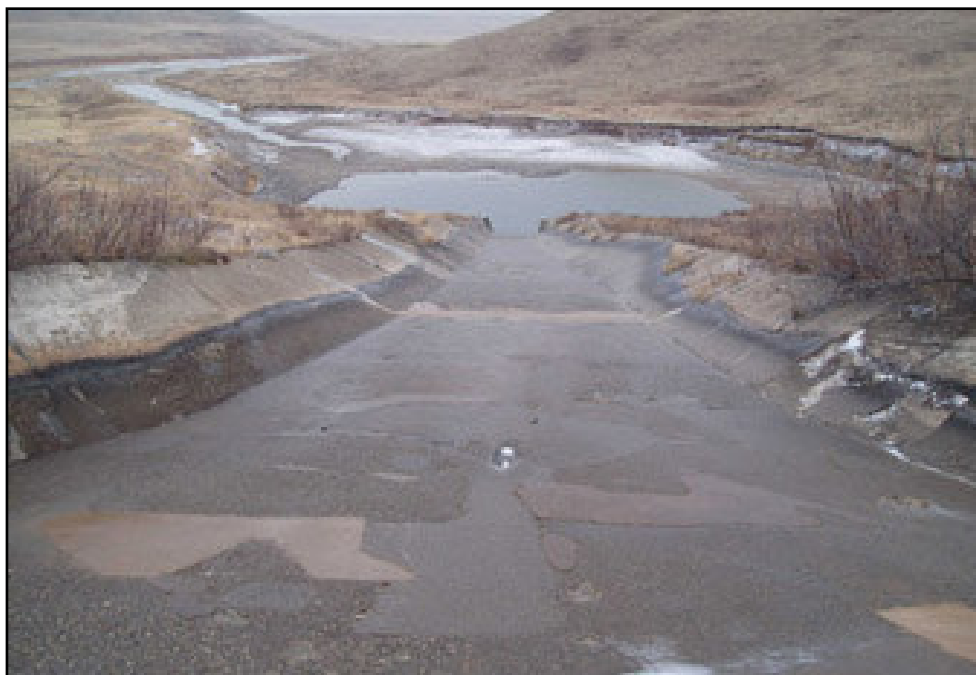
Drop No. 4 has a total length of approximately 340 feet and a vertical drop of approximately 67 feet. An overall view of the structure is shown in Figure 4.6.19. The chute is in poor to marginal condition as shown in Figure 4.6.20. There are several areas within the chute that have severe deterioration. For example, the deterioration in the chute slab (approximately 4 inches wide by 6 inches long) shown in Figure 4.6.21. and in the chute side wall slab (approximately 28 inches wide by 32 inches long) shown on the left side of Figure 4.6.22 is of concern. These deteriorated areas vary from partial depth to full depth of the concrete and could result in piping under the slab or complete blowout of the slab concrete if not corrected soon. Widespread spalling of the concrete is evident near the downstream end of the chute as shown in Figure 4.6.23.

Figure 4.6.20 Looking at chute section of Drop No. 4 (11/10/04).

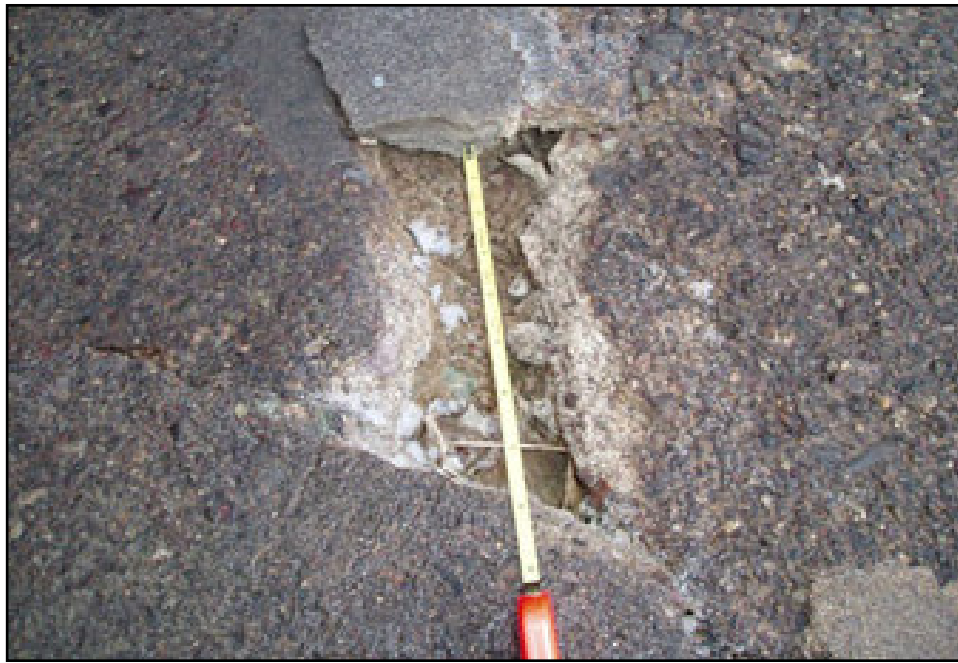
4.6.21 Close-up of concrete deterioration of Drop No. 4 chute floor (11/10/04).

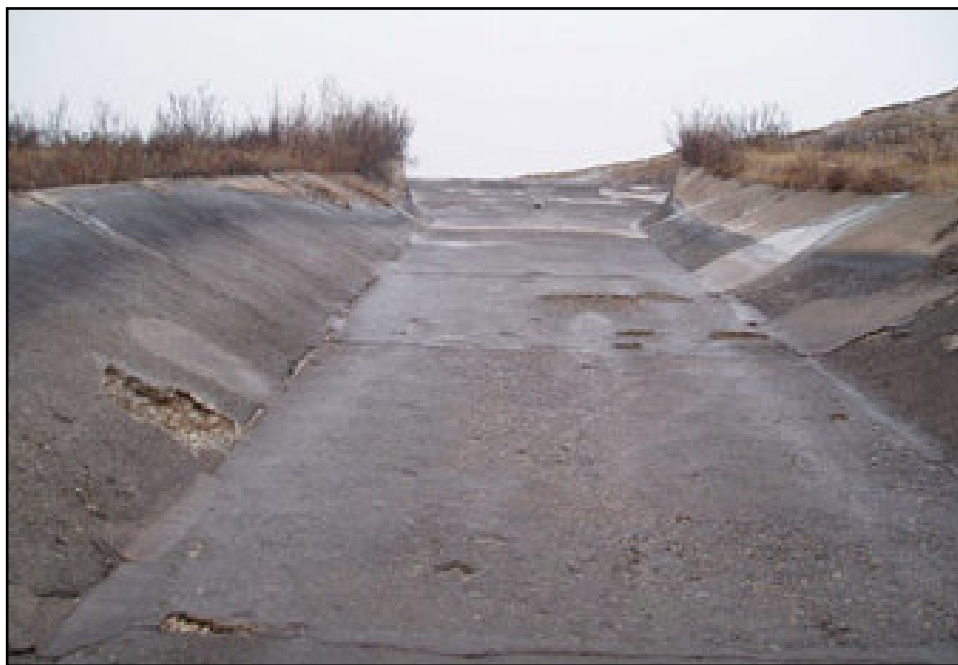
As is the case with the other drop structures, concrete deterioration and exposed rebar is visible on the vertical headwall of the plunge pool. Water in the plunge pool prevented a complete inspection of the condition of the lower walls or slab.

Figure 4.6.22 Looking upstream at Drop No. 4. Note concrete deterioration (11/10/04).

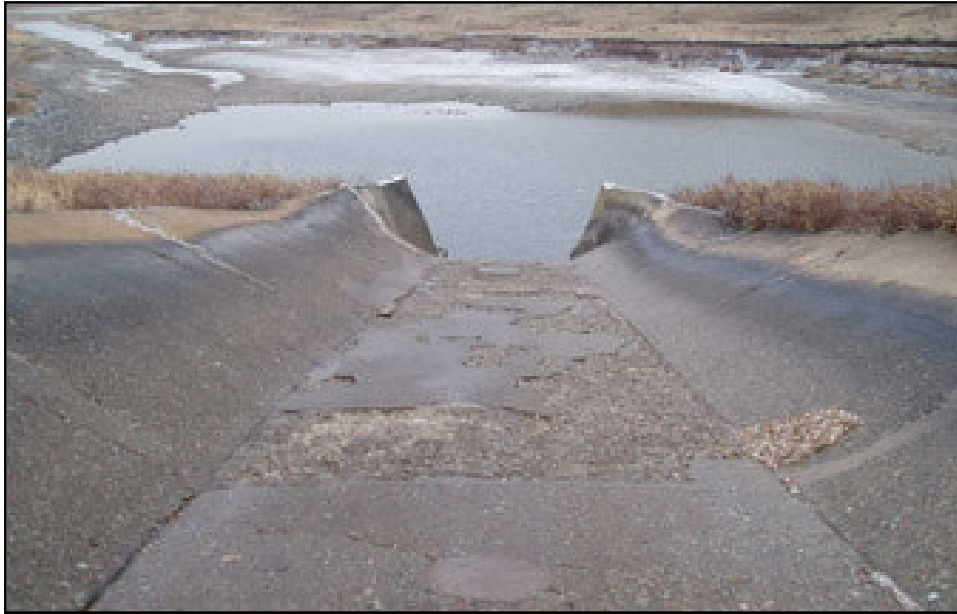
Figure 4.6.23 Looking at terminus of chute section (Drop No. 4). Note the degree of concrete spalling (11/10/04).

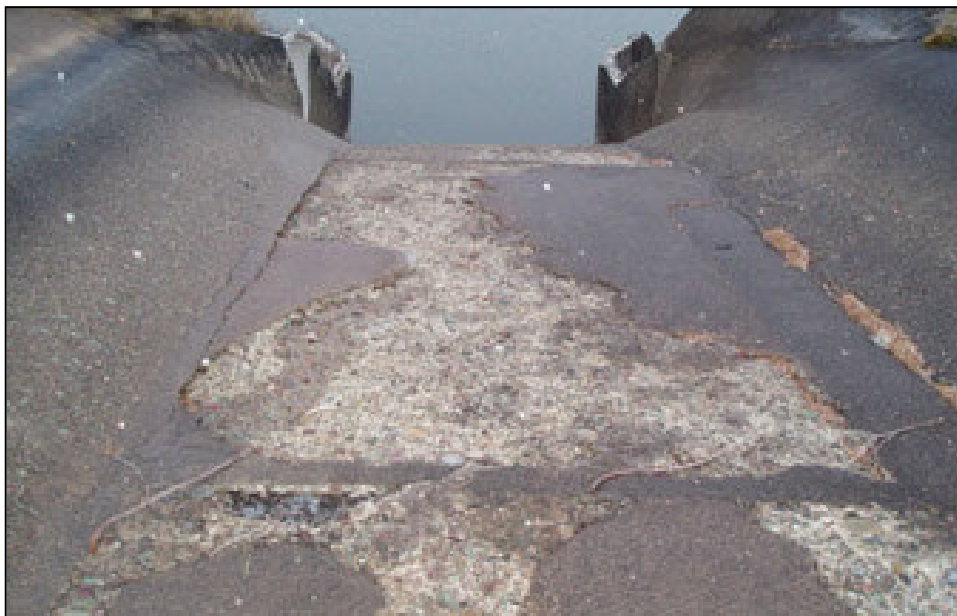
Drop No. 5 has a total length of approximately 259 feet and a vertical drop of approximately 57.3 feet. Past minor repairs to the chute and side walls are evident throughout the structure. Moderate to severe concrete spalling and cracking exists throughout the structure and the spalling is heaviest near the bottom of the slab as shown in Figure 4.6.24. The depth of the concrete deterioration in this section is between one to three inches.

Figure 4.6.24 Heavy spalling of chute floor in Drop No. 5 (11/10/04).

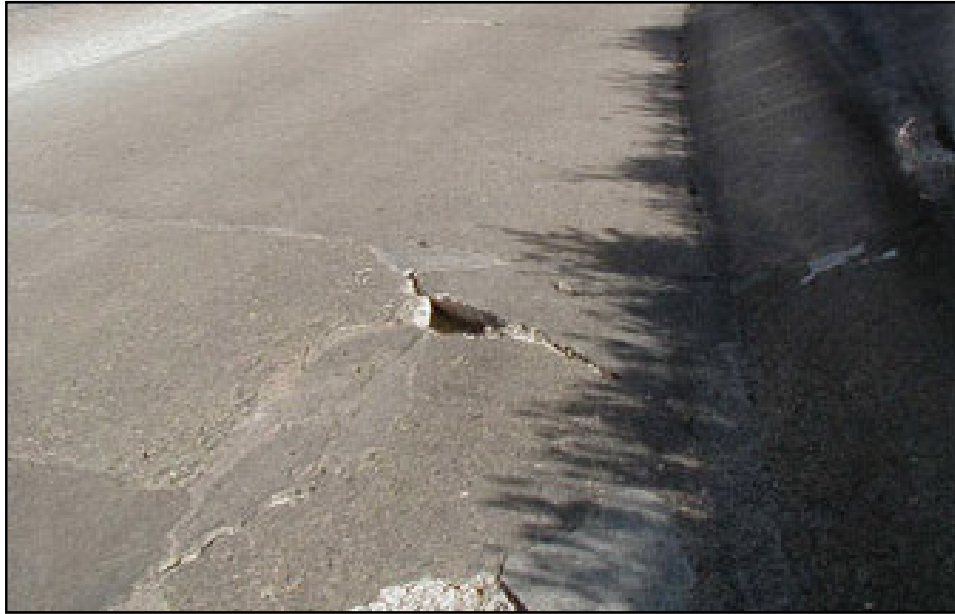
A couple of areas of severely deteriorated concrete in the chute slab are a concern. One of the areas is shown in Figure 4.6.25. This particular hole appears to be through the thickness of the slab and would likely lead to piping or complete blowout of the slab concrete if not corrected soon.

Figure 4.6.25 Hole in chute floor of Drop No. 5 (10/13/04).

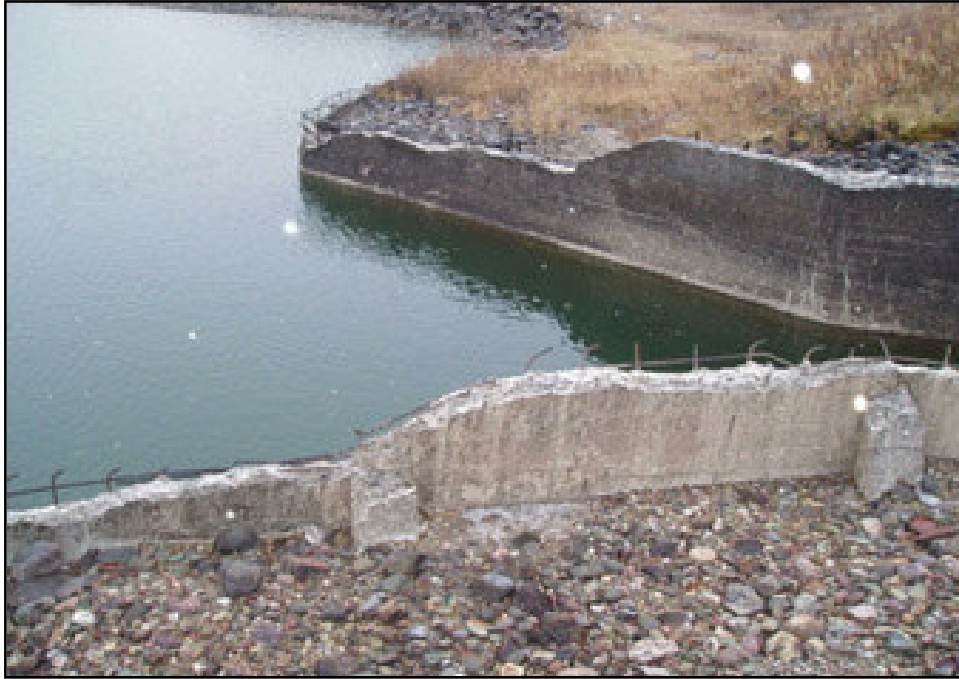
The training walls on both sides of the plunge pool are heavily eroded and damaged as shown in Figure 4.6.26. Exposed rebar beyond the top of both walls can be seen in the photo. The plunge pool water level was high during the inspection, so it was not possible to inspect the condition of the lower walls or slab. Exposed rebar and concrete deterioration is evident towards the top of the vertical face of the plunge pool as shown in Figure 4.6.27 around both drains.

Figure 4.6.26 Heavily damaged/eroded wing and training walls on Drop No. 5 (11/10/04).

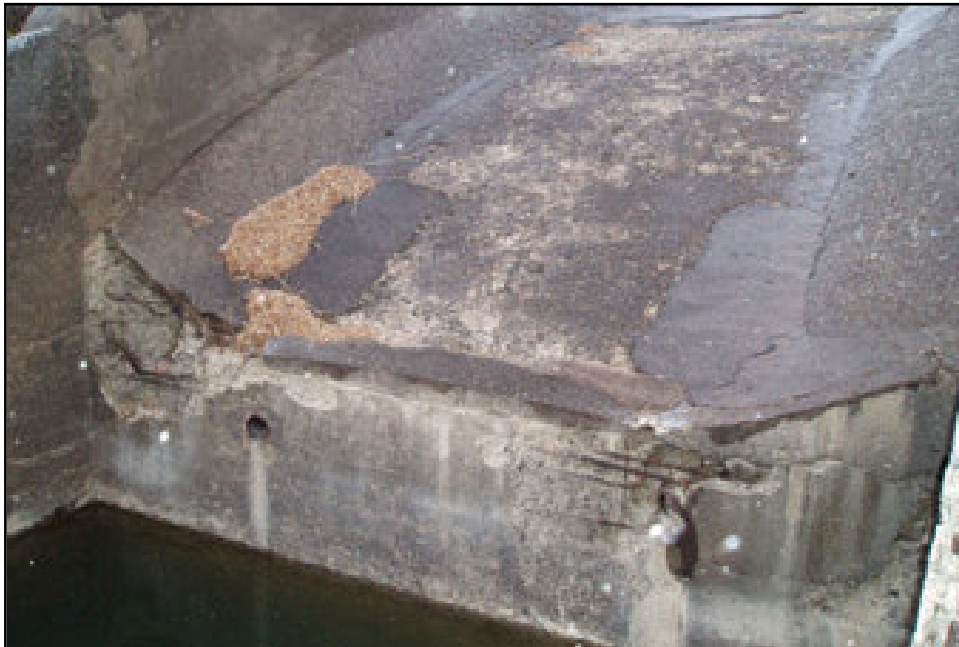
Figure 4.6.27 Terminus of chute section of Drop No. 5. Note condition of plunge pool headwall (11/10/04).
